# **Energy saving and passive solar thermal applications in rehabilitated municipal buildings in the town of Volos (Greece/Thessaly)**

Municipal Enterprise For Urban Studies and Construction/Regional Energy Centre of Thessaly (DEMEKAV/RECT) Laxana str, 5, 38334 Volos, Greece

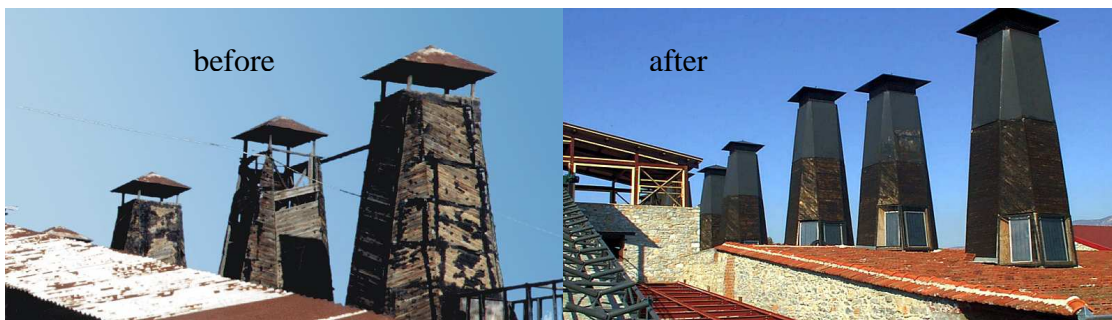
**Figure 2.** Chimneys of the old drying rooms before and after the rehabilitation. The rehabilitated chimneys function as solar chimneys for natural ventilation. The way the solar water heating collects were incorporated in the base of the chimneys, is also shown.

- Rehabilitation of the old chimneys to solar chimneys to enhance natural ventilation (fig. 2)
- Installation of solar water heating collectors on the old chimneys.
- Installation of double glazed sidewall windows to enhance direct solar gains.
- Insulation of the floor and of the roof.
- *in the new brick drying rooms → handcraft shops*
  - Installation of glazed wall, with glass bricks, to enhance direct solar gains and natural lighting.
  - Insulation of the whole shell of the building and of the floor.
  - Installation of electronic light modulators.
  - Adaptation of a solar atrium connecting the old and the new brick drying rooms.

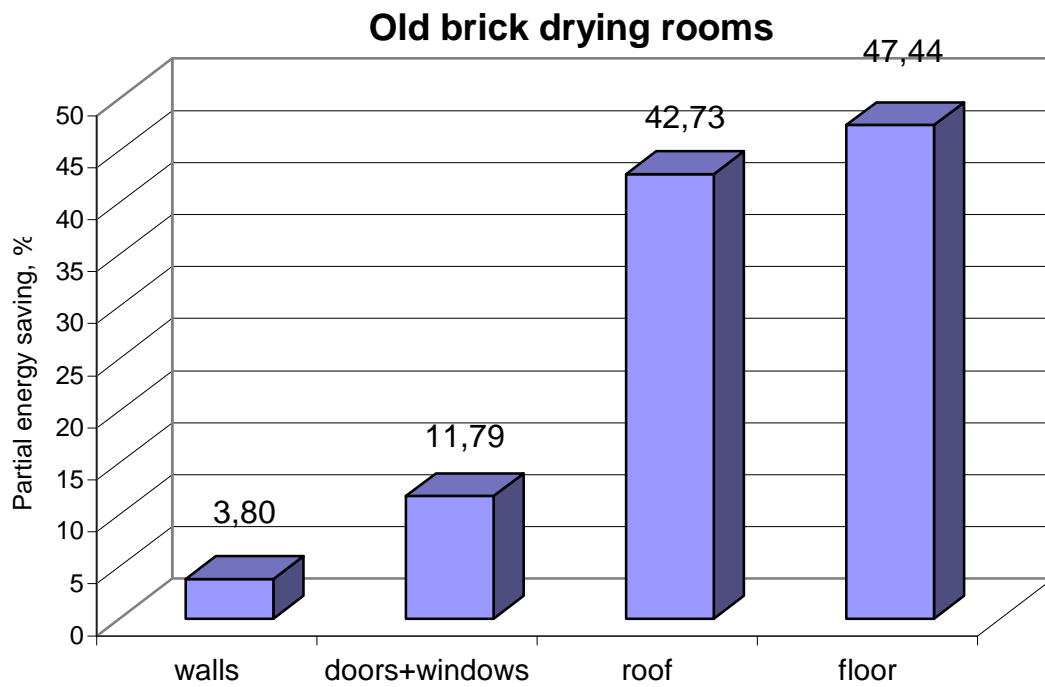
**Figure 3.** Expected energy saving in the old brick drying rooms due to the interventions realized, compared to the initial state of the building.

However, the expected energy saving from the above-mentioned interventions in the old and new brick drying rooms and in the kiln, are shown in figures 3, 4 and 5, respectively.

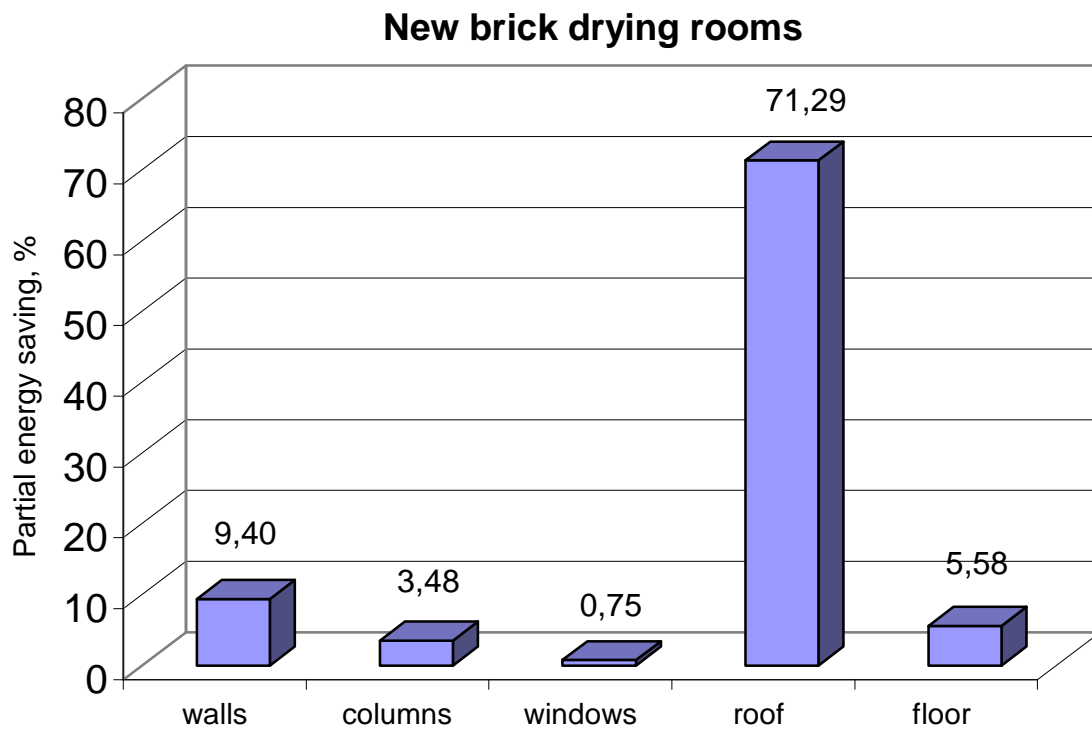
**Figure 4.** Expected energy saving in the new brick drying rooms due to the interventions realized, compared to the initial state of the building.

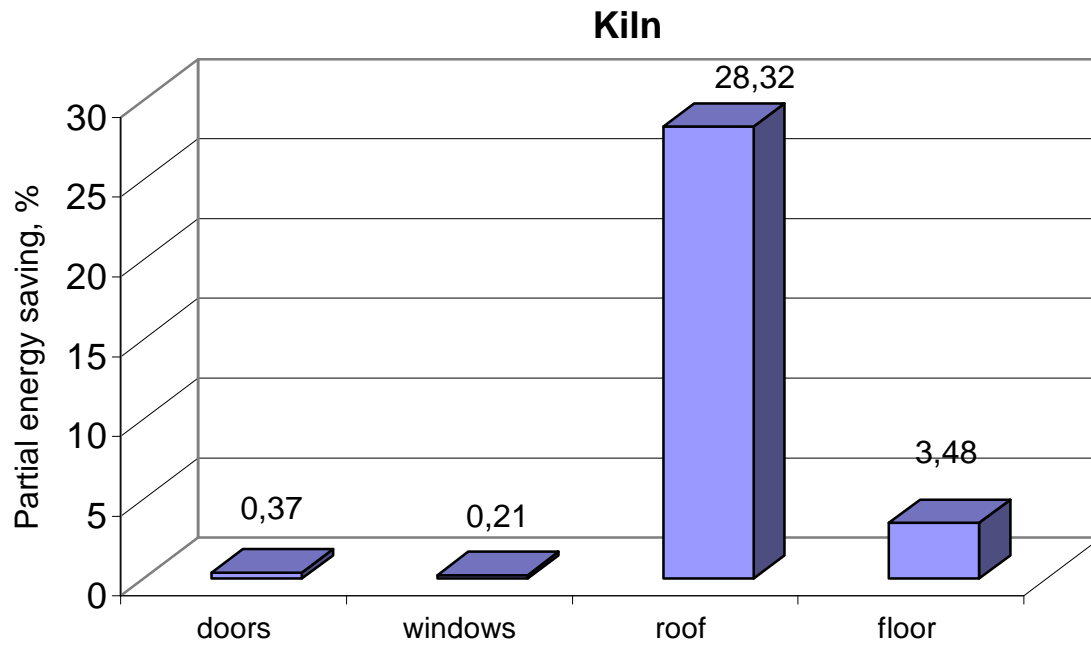
**Figure 5.** Expected energy saving in the kiln due to the interventions realized, compared to the initial state of the building.

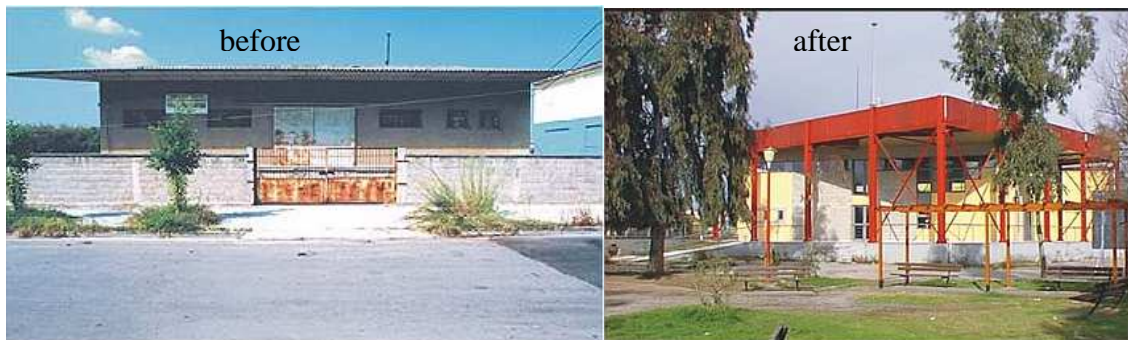
**Figure 6.** The old grain sanitation building (before) transformed to the new bioclimatic building hosting the Regional Energy Center of Thessaly (after).

The grain sanitation building is located in the south-west part of the city and was owned by the Ministry of Agriculture. Sanitation was realized by fumigation using methyl bromide. The operation of the site ceased in 1975 and remained closed for 20 years. Finally in 1995, the building was granted to the Municipality of Volos, for 20 years, in the state shown in figure 6(before).

The building was in such a state that it could not be imagined that it could serve any other purpose. However, the imagination of local architects and engineers transformed this building to the state shown in figure 6 (after), incorporating in it several elements of modern bioclimatic design.
